0239-L-21/6

# Test report

Allshield Blue 2C coating + EKLTM 800 /  
450 reinforcement / Eco Prim Grip primer / Cosmofin FG /  
Fisprofi 5,0 × 120 mm fastener + Ø 70 metal washer /  
Unidek Platinum Kameleon / trapezoidal steel deck

3 November 2021  
0239-L-21/6  
A.R. Hameete  
test on external fire exposure to roofs in  
combination with photovoltaic (PV)  
arrays according to the principles of  
CLC/TR 50670

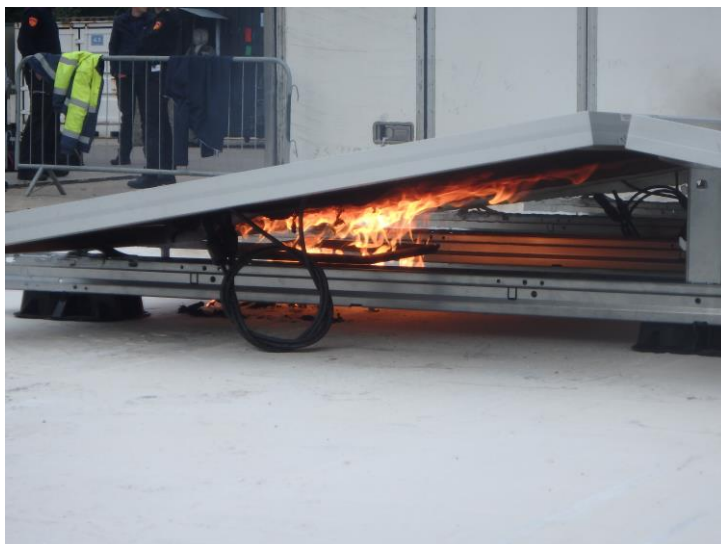
**Photo 3**

| Description | Result [min:s] | | | |
|---|---|---|---|---|
| Roofing burning | 3:30 <sup>1)</sup> | | | |
| <sup>1)</sup> The roofing did not catch fire; this time refers to the PV module.<br><sup>2)</sup> Length of fire spread measured from the edge the projection of the gas burner on to the exposed specimen surface.<br><sup>3)</sup> Not been reached. | | | | |

The PV module is burning.

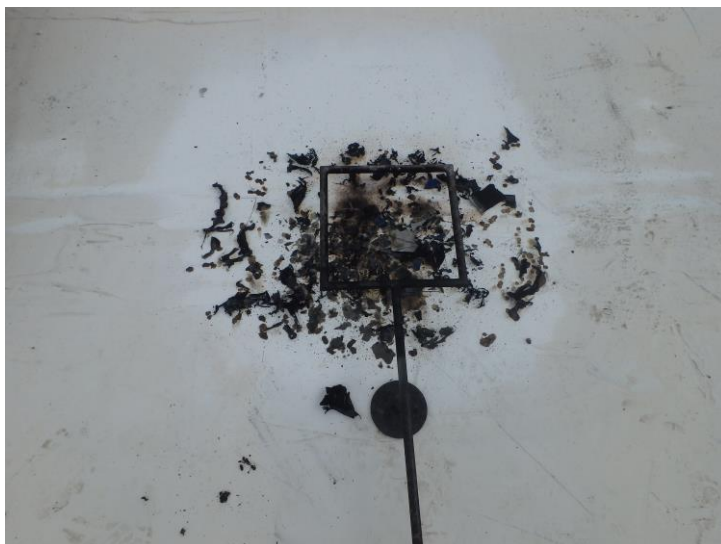
**Photo 5**

The coating did not catch fire so there was no spread of fire on the surface of the test specimen.

Overview of the damaged area of the coating.

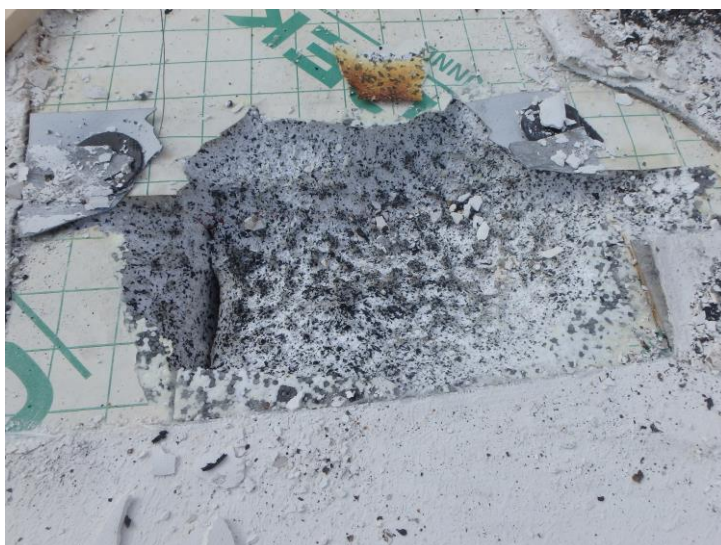
**Photo 6**

The burner has been turned off after 10:00 (min:s); the flames were directly gone. After 15 minutes the temperature has reached 135 °C in the middle of the insulation, after this time the temperature decreased.

Overview of the damaged area of the thermal insulation.
